Impact of Hurricane Katrina on Roadways in the New Orleans Area

Technical Assistance Report No. 07-2TA

Louisiana Department of Transportation and Development
Louisiana Transportation Research Center

March 2007

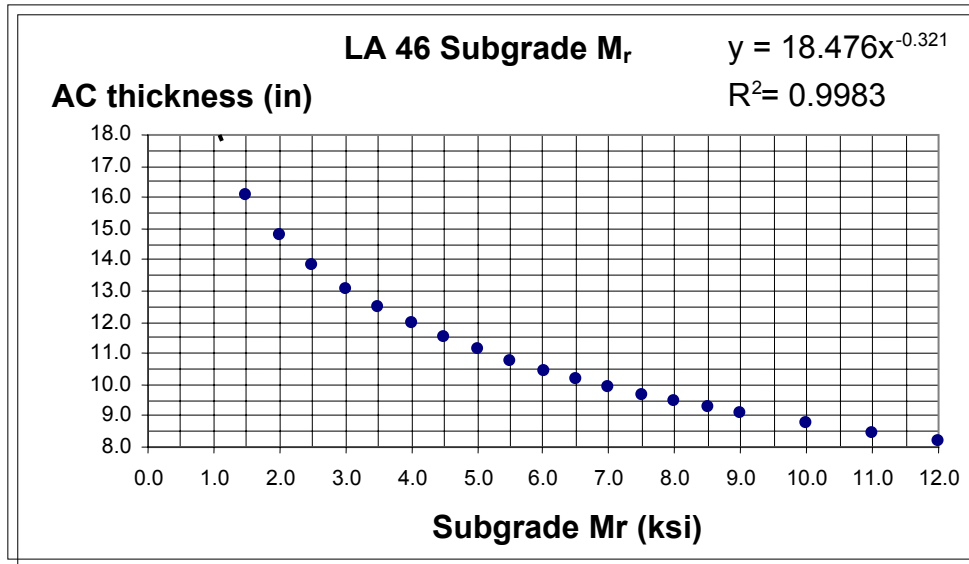
Figure 7
AC versus subgrade M_r (LA 46)

Using the output from the DARWIN pavement design, a curve can be created that shows how SN would vary as the subgrade M_r is changed for a given traffic load level. Figure 7 provides an example using data generated from the LA 46 pavement which is the only pavement in the study for which before and after data exists (example DARWIN tables are presented in Appendix D). If the subgrade resilient modulus is 6 ksi, then the required pavement thickness would be 10.5 in. If the subgrade resilient modulus is reduced to 3 ksi, then the required pavement thickness would be 13 in. Using this methodology, an equivalent amount of pavement thickness can be assigned due to the reduction of subgrade modulus. In this example, it would be 2.5 inches of pavement.

It is evident from the test results that this roadway was weakened by the hurricane-flood waters. It would take an asphalt concrete overlay of approximately 3 in. to mitigate the damages $((0.9 \text{ SN}/0.44) + (10 \text{ in}-9.0 \text{ in. for } M_r \text{ from Figure 7}) = 2.04 + 1.0 = 3.0 \text{ in.})$.

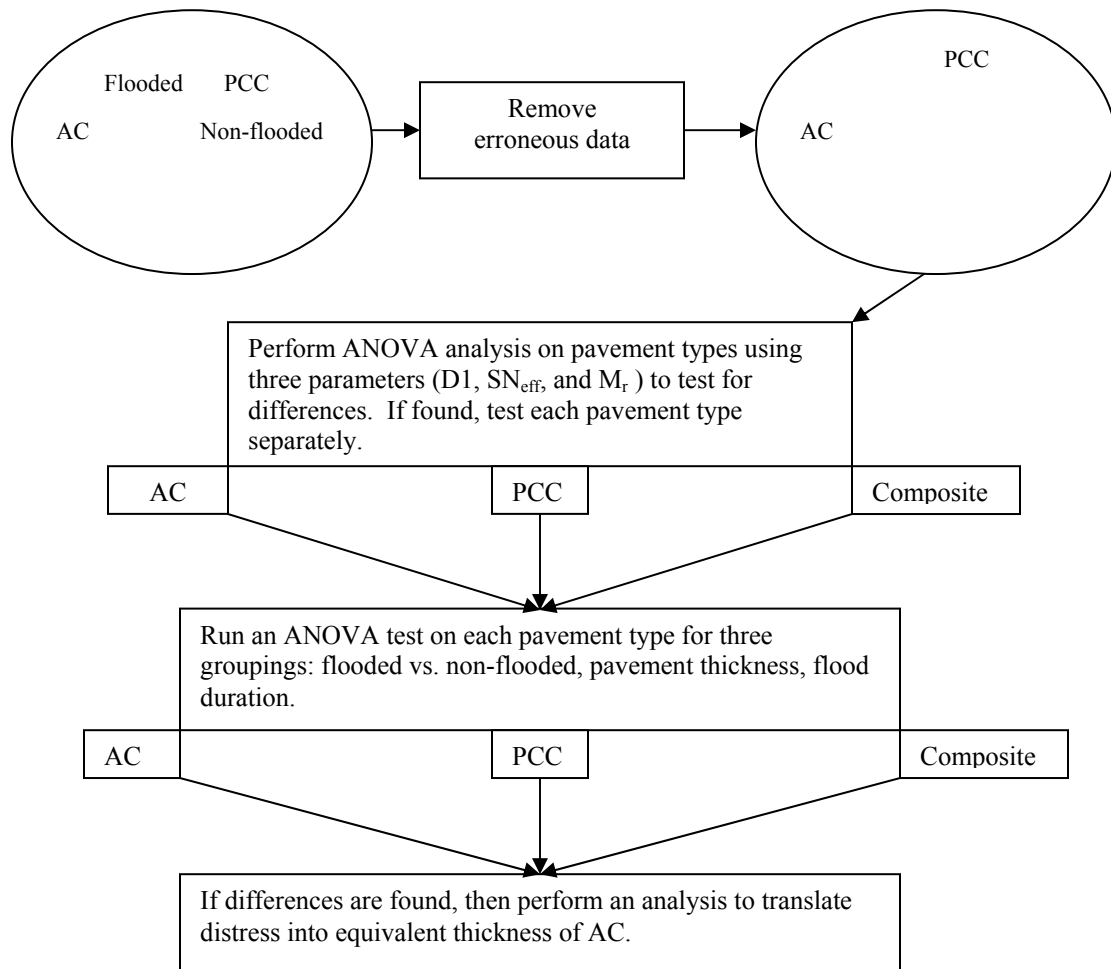
Figure 8
Analysis flow chart

Figure 8 presents a flow chart of the statistical methods and methodology used to analyze the Fugro data.

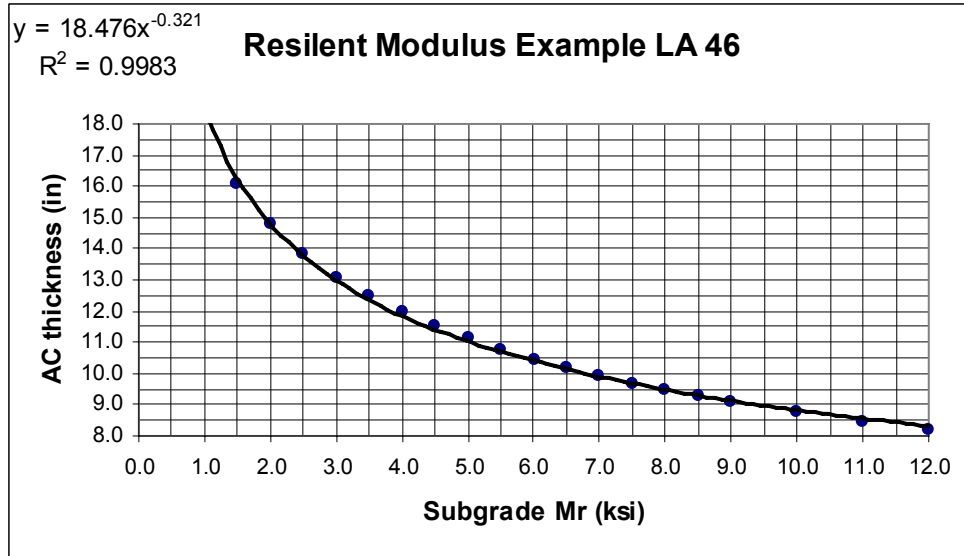
Figure D-1
AC versus subgrade M_r (LA 46)

AC thickness = SN / 0.44 SN/in
